Ortho Clinical Diagnostics

September 21, 2022

**URGENT PRODUCT CORRECTION NOTIFICATION**

**ORTHO VISION® Analyzer and ORTHO VISION® Max Analyzer for ID-MTS™ Gel Cards: Potential Use of Mismatched Camera Images During Routine Imaging Operations**

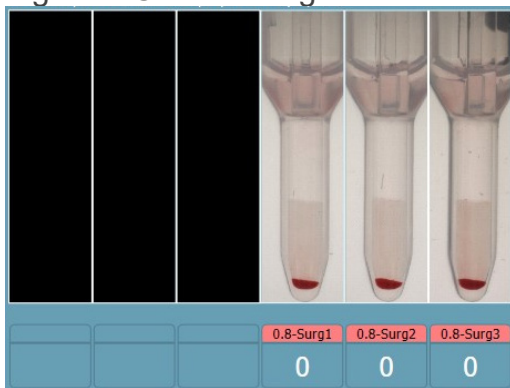
Figure 1: Correct Image

The following images are examples of an order Results Details screen where Figure 1 shows a normal image reviewed in color and figure 2 shows an unusual color pattern when reviewed in color. Figure 2 is an example of the use of mismatched MTS images by CIMS.

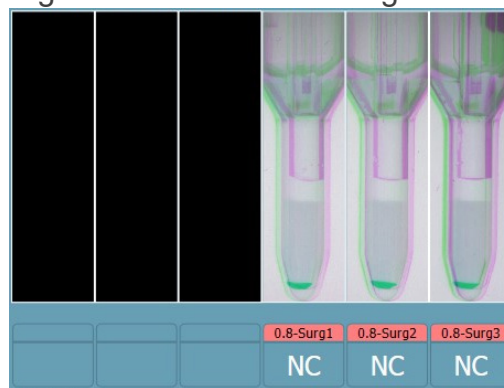
Figure 2: Mismatched Image

Under an atypical software anomaly, a customer observed that images used for analysis of a test result did not come from the front and back sides of the same card. Ortho determined that the CIMS processed images out of synchronization (images captured earliest in sequence are placed at the top of the queue to be processed). As a result, image processing software utilized on the ORTHO VISION analyzer may use mismatched front of card and back of card images for column grading and result interpretation.

Until a software update is available, and when the ORTHO VISION analyzer posts a CIMS28, CIMS33, CIMS35, or a CIMS02 error code, please abort all tests in process, shut down the system and restart the analyzer. Restarting the analyzer will reset the software and resynchronize camera images to resolve the use of mismatched images.

This software anomaly will be resolved in the next software update, currently expected to be available before or during Q1 of 2023. Ortho will notify you when the software update is published for installation.
