Ortho Clinical Diagnostics

September 21, 2022

URGENT PRODUCT CORRECTION NOTIFICATION

ORTHO VISION® Analyzer and ORTHO VISION® Max Analyzer for ID-MTS™ Gel Cards: Potential Use of Mismatched Camera Images During Routine Imaging Operations

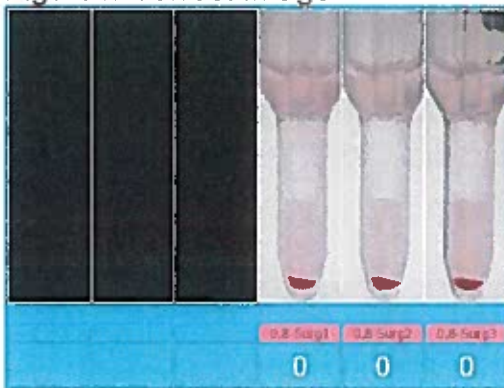
Figure 1: Correct Image

The following images are examples of an order Results Details screen where Figure 1 shows a normal image reviewed in color and figure 2 shows an unusual color pattern when reviewed in color. Figure 2 is an example of the use of mismatched MTS images by CIMS.

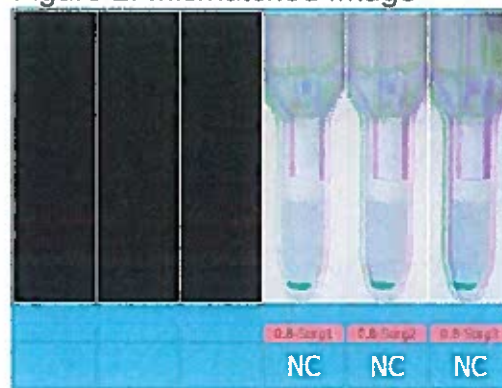
Figure 2: Mismatched Image

Under an atypical software anomaly, a customer observed that images used for analysis of a test result did not come from the front and back sides of the same card. Ortho determined that the CIMS processed images out of synchronization (images captured earliest in sequence are placed at the top of the queue to be processed). As a result, image processing software utilized on the ORTHO VISION analyzer may use mismatched front of card and back of card images for column grading and result interpretation.

The use of mismatched camera images can also be reviewed for any test which has had column level grading performed, even if the grading has resulted in an invalid test interpretation (e.g., Indeterminate or Wrong Liquid Level code is generated). When using mismatched camera images, the color images in the Results Details screen exhibit unusual color patterns, which may support the identification of the mismatched images for the order.

Until a software update is available, and when the ORTHO VISION analyzer posts a CIMS28, CIMS33, CIMS35, or a CIMS02 error code, please abort all tests in process, shut down the system and restart the analyzer. Restarting the analyzer will reset the software and resynchronize camera images to resolve the use of mismatched images.

This software anomaly will be resolved in the next software update, currently expected to be available before or during Q1 of 2023. Ortho will notify you when the software update is published for installation.
