September 21, 2022

**URGENT PRODUCT CORRECTION NOTIFICATION**

**ORTHO VISION® Analyzer and ORTHO VISION® Max Analyzer for ID-MTS™ Gel Cards: Potential Use of Mismatched Camera Images During Routine Imaging Operations**

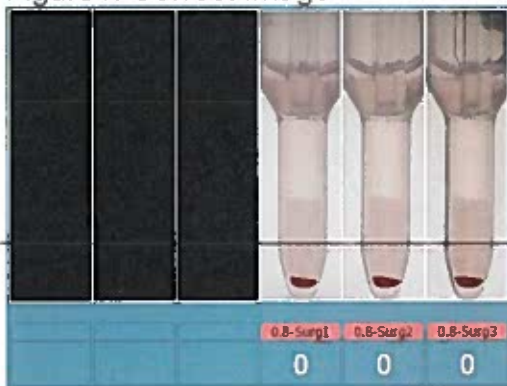
Figure 1: Correct Image

The following images are examples of an order Results Details screen where Figure 1 shows a normal image reviewed in color and figure 2 shows an unusual color pattern when reviewed in color. Figure 2 is an example of the use of mismatched MTS images by CIMS.

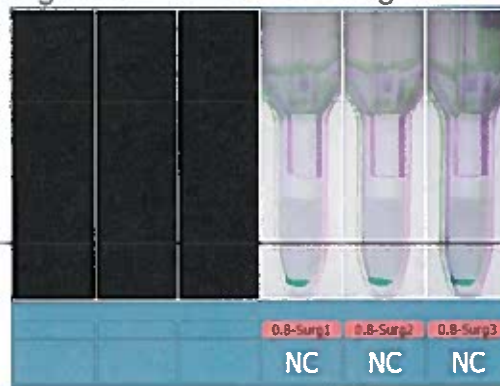
Figure 2: Mismatched Image

Under an atypical software anomaly, a customer observed that images used for analysis of a test result did not come from the front and back sides of the same card. Ortho determined that the CIMS processed images out of synchronization (images captured earliest in sequence are placed at the top of the queue to be processed). As a result, image processing software utilized on the ORTHO VISION analyzer may use mismatched front of card and back of card images for column grading and result interpretation.

The use of mismatched camera images can also be reviewed for any test which has had column level grading performed, even if the grading has resulted in an invalid test interpretation (e.g., Indeterminate or Wrong Liquid Level code is generated). When using mismatched camera images, the color images in the Results Details screen exhibit unusual color patterns, which may support the identification of the mismatched images for the order.

Until a software update is available, and when the ORTHO VISION analyzer posts a CIMS28, CIMS33, CIMS35, or a CIMS02 error code, please abort all tests in process, shut down the system and restart the analyzer. Restarting the analyzer will reset the software and resynchronize camera images to resolve the use of mismatched images.

This software anomaly will be resolved in the next software update, currently expected to be available before or during Q1 of 2023. Ortho will notify you when the software update is published for installation.
