Urgent Medical Device Correction Updated Information

VC-16-01A.B.US June 3, 2016

Dimension Vista® System

Blood Urea Nitrogen (BUN) Flex® Reagent Cartridge Well-to-Well Accuracy Shifts

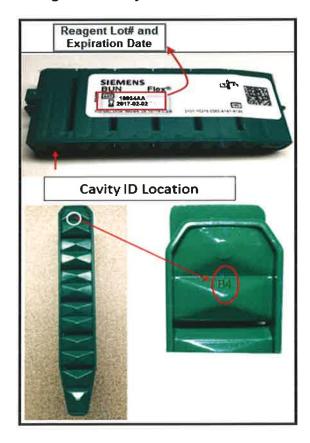
Figure 1 Cavity Identification

Siemens preliminary investigation determined cavity B4 is impacted. In our efforts to work with customers to ensure the integrity of BUN results while further internal investigation is being conducted the following actions are recommended. The actions below will aid in the detection of affected reagent well sets. The use of the combined Actions #1, #2 and #3 are strongly recommended to minimize the usage of affected reagent wells.

- Each Vista BUN Flex reagent cartridge has a mold/cavity identification on the bottom.
- Inspect the bottom of each Vista BUN Flex reagent cartridge of the affected lots listed in Table 1.
- Identify the cavity numbers as shown in Figure 1
- Siemens recommends removing the individually wrapped flexes of the impacted Vista BUN lots only as needed rather than all at once.
- Discard all Vista BUN Flex reagent cartridges with cavity number B4. Vista BUN Flex
 reagent cartridges that do not have cavity number B4 may continue to be used. The
 remaining reagent cartridges may then be loaded onboard the instrument for use
 however, actions #2 and #3 are strongly recommended.

Action #1: Inspect the Vista BUN flex mold/cavity and discard flexes with cavity B4

Discard all Vista BUN Flex reagent cartridges with cavity number B4 (as described on Figure 1)
