Instructions to Verify Temperature using VITROS® 3600/5600 Systems

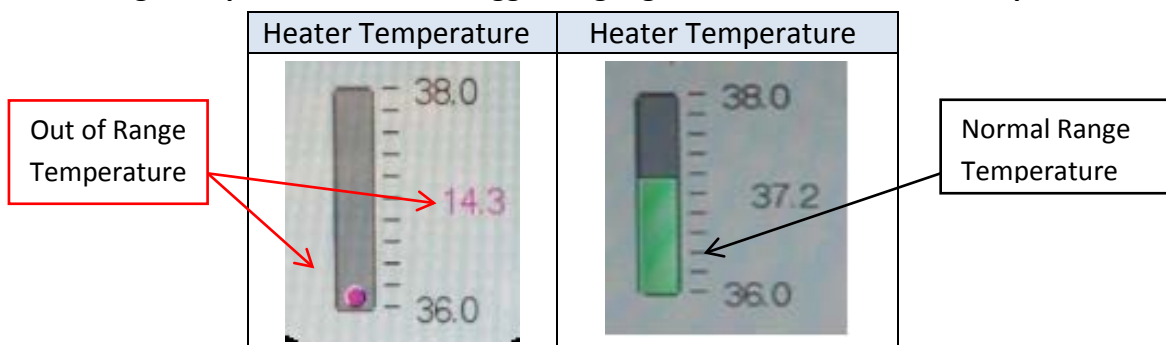
Out of range temperatures will be flagged/highlighted as shown in the example below

- Select '*Diagnostics*'
- Power **off** Circuit Breaker (CB) 14
- Power **on** Circuit Breaker (CB) 14, wait 20 seconds after the last PER-328 condition code occurs
- Exit '*Diagnostics*' to initialize the system
- Contact your Ortho-trained field service representative to resolve the Thermistor issue.
