Ortho Clinical Diagnostics

September 21, 2022

URGENT PRODUCT CORRECTION NOTIFICATION

ORTHO VISION® Analyzer and ORTHO VISION® Max Analyzer for ID-MTS™ Gel Cards: Potential Use of Mismatched Camera Images During Routine Imaging Operations

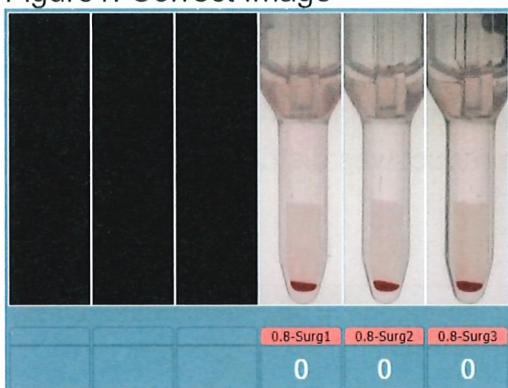
Figure1: Correct Image

The following images are examples of an order Results Details screen where Figure 1 shows a normal image reviewed in color and figure 2 shows an unusual color pattern when reviewed in color. Figure 2 is an example of the use of mismatched MTS images by CIMS.

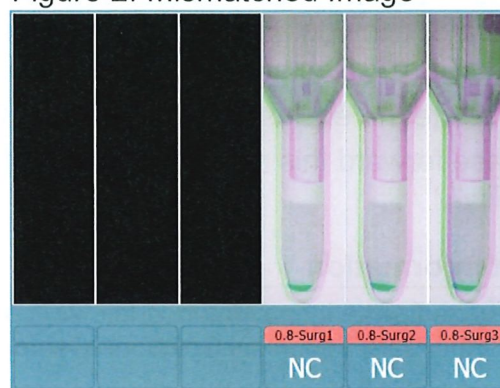
Figure 2: Mismatched Image

Under an atypical software anomaly, a customer observed that images used for analysis of a test result did not come from the front and back sides of the same card. Ortho determined that the CIMS processed images out of synchronization (images captured earliest in sequence are placed at the top of the queue to be processed). As a result, image processing software utilized on the ORTHO VISION analyzer may use mismatched front of card and back of card images for column grading and result interpretation.

The use of mismatched camera images can also be reviewed for any test which has had column level grading performed, even if the grading has resulted in an invalid test interpretation (e.g., Indeterminate or Wrong Liquid Level code is generated). When using mismatched camera images, the color images in the Results Details screen exhibit unusual color patterns, which may support the identification of the mismatched images for the order.

Until a software update is available, and when the ORTHO VISION analyzer posts a CIMS28, CIMS33, CIMS35, or a CIMS02 error code, please abort all tests in process, shut down the system and restart the analyzer. Restarting the analyzer will reset the software and resynchronize camera images to resolve the use of mismatched images.

This software anomaly will be resolved in the next software update, currently expected to be available before or during Q1 of 2023. Ortho will notify you when the software update is published for installation.
