Laboratories at Adventist Healthcare Washington Adventist Hospital, Shady Grove Medical Center and Germantown Emergency Center

LABORATORY ALERT

BUN Flex Reagent Cartridge Well-to-Well Accuracy Shifts

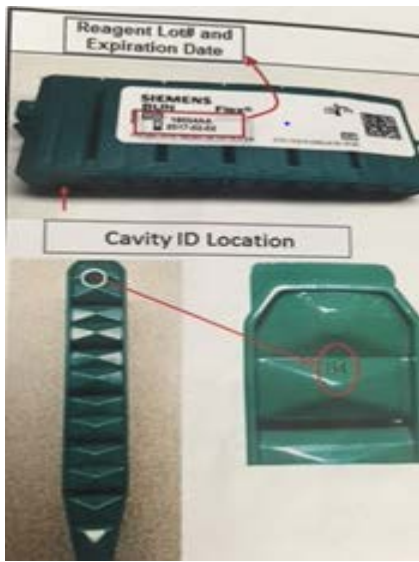
<p>The figure shows a Siemens BUN Flex reagent cartridge. The top part of the image shows the cartridge with a label that includes 'Reagent Lot# and Expiration Date'. The bottom part of the image shows the cartridge with a label that includes 'Cavity ID Location'. A red circle highlights the cavity ID location on the cartridge.</p>

Reagent Name:	BUN Reagent Flex current and all future lot numbers
Issue identified:	Siemens issued letter informing customers of well-to-well accuracy shifts for specific lots of Dimension Vista BUN causing inaccurate patient and/or Quality Control results. The investigation demonstrated loss of enzymatic activity of the GLDH reagent wells made from a specific mold/cavity.
Action to Take:	<ol style="list-style-type: none"> 1. Identify the cavity numbers as shown in Figure 1 below. 2. Siemens recommends removing individually wrapped flexes of the BUN reagent as needed rather than all at once. 3. Discard all Vista BUN flex reagent cartridges with cavity number B4.
Figure 1:
